Letter from VTA

**RE: *Item 10.2 – October 20, 2020 City Council Agenda:
C19-013, CP19-013 and T20-015 – Conforming Rezoning, Conditional Use Permit,
and Tentative Map for Certain Real Property Located at 550-570 Meridian Avenue,
1401 Parkmoor Avenue, and 529, 592, and 691 Race Street***

San Jose Vasona Quiet Zone Diagnostic Review Comments & Responses

DATE: August 6, 2019 (Day 1)

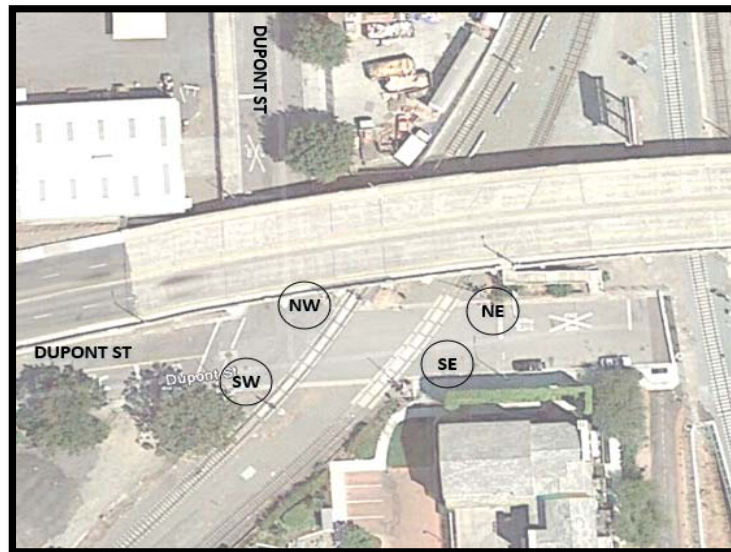
DUPONT ST

Comments		Response
<i>General</i>		
1	Crash History 2007 - 2019: none	n/a - informational comment
2	Land Uses: trail and residential multifamily at southeast quadrant; residential multifamily developments proposed at southwest and northwest quadrants	n/a - informational comment
3	This crossing is a good candidate for closure to regular vehicular traffic on the east leg since it dead-ends	Placement of a barricade along the west side of the tracks with 8.5' side clearance from the track was evaluated and deemed infeasible because the eastbound left turn movement overlaps with the rail envelope.
4	This is a 4-quadrant gate system without vehicle presence detection; current CPUC standard is to have vehicle presence detection; if any electrical alterations were made to this system, CPUC would require vehicle presence detection to be incorporated	n/a - informational comment
5	While diagnostic review was being conducted, a bicyclist ignored activated warning devices and rode through the crossing	n/a - informational comment

<i>SE quadrant</i>		
6	There is no sidewalk in between the tracks on the south side of the street; this leads pedestrians to enter the roadway in order to cross the tracks; connect the sidewalk over the tracks to keep pedestrians on the sidewalk	City staff and VTA are coordinating to seek developer contributions towards sidewalk and pedestrian treatments as part of the proposed developments on the southwest quadrant of the crossing.
7	The gate is missing bells and missing flashers facing eastbound	See Dupont Comment Response #6. Addition of bells and flashers could be incorporated into the improvements.
8	Signage ineffective – doesn't tell pedestrian what they need to do – there is no channelization	See Dupont Comment Response #6.
<i>NE quadrant</i>

9	There is a staircase connecting Dupont St with the San Carlos St Bridge; there is no sidewalk on the north side of Dupont St, and the staircase offloads pedestrians into the roadway; there is no channelization for pedestrians headed across the tracks; improve	See Dupont Comment Response #6 for planned improvements. In the longer term, the Diridon Station Integrated Concept Plan is a joint planning effort by City of San Jose, VTA, CA High Speed Rail Authority, and Caltrain to redesign Diridon station. On December 3, 2019, San Jose City Council endorsed the plan's recommended spatial layout of the station, which includes elevating the station. The raised station requires removal of the San Carlos Street Bridge and staircase, and a complete redesign of the Dupont Street crossing.
10	There is a chain link fence along the north edge of Dupont St at this quadrant; the fence is obstructing view of the warning signs; remove fence or push it north away from roadway	Caltrain placed the fence there temporarily during a construction project. The fence has been removed.

<i>NW quadrant</i>		
11	Gate is missing flashers facing east, and missing bells	Comment for VTA. Also see Dupont Comment Response #9.
12	Gate does not meet current MUTCD standard clearance requirement of 4'3" between the center of the pole and the face of curb	Comment for VTA. Also see Dupont Comment Response #9.
13	Gate does not meet current standard clearance required between the counterweight and the bridge pier	Comment for VTA. Also see Dupont Comment Response #9.
14	Roadway appears to be recently paved; verify required striping is put in place	Required pavement markings were recently installed (Fall 2019) on the north and west legs.
15	Need W-48CA (2 Tracks) underneath the W10-4	See proposed signage and striping plans in Attachment K. This sign will be added.
<i>SW quadrant</i>		
16	Check height of flashers – appears low	Comment for VTA.
17	Check pole clearance to face of curb	Comment for VTA. Also see Dupont Comment Response #9.

18	Especially because of the track skew, future development on the private property at this corner should maximize pedestrian line of sight down the tracks to see oncoming trains	City staff will carry this comment through the development review cycle for the proposed development adjacent to the southwest quadrant of the crossing. The latest plan submittal for the development shows the northeast corner of the proposed building setback approximately 35' west from the nearest track and 40' south from the existing face of curb.
19	Visibility – Trees	The existing trees at the northeast corner of the lot adjacent to the rail corridor will be removed by the proposed development. We will also ensure that the development does not place trees or other obstacles near the crossing that would obstruct line of sight down the rail corridor.

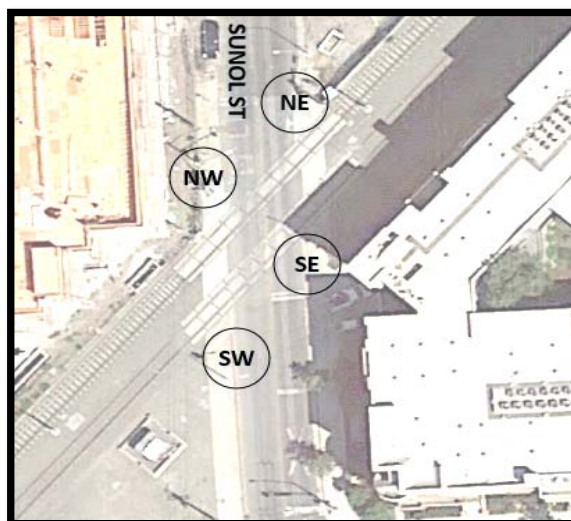
SUNOL ST

Comments		Response
<i>General</i>		
1	<p>Crash History 2007 - 2019:</p> <ul style="list-style-type: none"> • 3/12/13 Injury: southbound pedestrian in northeast quadrant hit by northbound LRT; pedestrian suffered injuries when pedestrian entered crossing against activated warning devices and was struck by the LRT • 6/8/13 Fatality: southbound bicyclist in northwest quadrant hit by northbound LRT; bicyclist rode into crossing against activated warning devices and was struck and killed by LRT 	n/a - informational comment
2	<p>Land Uses: This area used to be industrial; now high density residential and a nearby park, which will generate more pedestrian traffic</p>	n/a - informational comment
3	<p>Adjacent developments and anticipated pedestrian traffic warrant full pedestrian treatments (automated pedestrian gate, pedestrian swing gate, channelization, and detectable warning strip) at all quadrants</p>	See Attachment L for proposed gates. Pedestrian treatments at all quadrants are proposed.

4	<p>History: There were a few meetings at Sunol and Auzerais crossings in the past to improve the crossing with the new development; VTA, CPUC, and construction inspectors from CSJ attended; developer always disappeared following CPUC and VTA comments; CSJ needs a process to condition upgrades to crossings in planning phase of developments; recently, CSJ obtained \$1M from the developer to use towards improvements at the Sunol and/or Auzerais crossings; CSJ is coordinating with VTA to have VTA construct comprehensive improvements as part of their Pedestrian Back Gates Project and be reimbursed by CSJ</p>	See General Comment Response #14.
5	<p>4 quadrant gate system is the only SSM available due to driveways</p>	See Attachment L for proposed gates. A 4-quadrant gate system is proposed.
<i>SE quadrant</i>		
6	<p>Refresh pavement markings for northbound direction</p>	See proposed signage and striping plans in Attachment K. These pavement markings will be refreshed.

7	NB stop bar doesn't appear compliant; new requirement is a single 24" wide bar	See proposed signage and striping plans in Attachment K. This stop bar will be replaced.
8	There is a driveway that appears to just serve trash collection; this is a bad location just south of the crossing because trash collection vehicles can block traffic's view of the crossing; some vehicles could circumvent the trash collection vehicle and enter the rail crossing when trains are approaching; close this driveway or install a 4-quadrant gate system to mitigate this risk	We reached out to the Monte Vista property management and HOA and offered to close the driveway at no cost to them. They considered it but ultimately decided not to close the driveway because of concerns with using another driveway for trash collection.
9	Remove the two trees on the sidewalk on the east side of Sunol, south of the crossing; these trees block view of the crossing warning devices	The trees in question are juvenile specimens. At maturity, these trees will have a height of over sixty feet and will allow the crown to be maintained at our standard fourteen feet over the roadway to provide adequate clearance for larger vehicles and should not present a long term issue for visibility at the crossing. In the interim, these trees have been raised to between eight and ten feet to provide visibility of the warning signs and devices. This will likely stimulate additional upward growth at the top and allow for a more permanent clearance pruning in 2-3 years.

<i>NE quadrant</i>		
10	Remove "No Left Turn" sign facing northbound traffic since there is no longer a driveway to turn into	See proposed signage and striping plans in Attachment K. This sign will be removed.
11	The slatted fence along the rail corridor blocks views for southbound traffic of trains coming from the north; remove or replace with a fence that doesn't block visibility	Comment for VTA.
12	Remove the nonstandard "No Train Horn" sign that is mounted on the streetlight pole	See proposed signage and striping plans in Attachment K. This sign will be removed.
13	There is an Emergency Vehicle Access driveway within 60 feet of the crossing; this is problematic because vehicles using this driveway can cause downstream traffic to queue over the tracks	See Attachment L for proposed gates. A 4-quadrant gate system is proposed.
<i>NW quadrant</i>		
14	Replace defective gate arm (immediate action item unrelated to quiet diagnostic meeting)	VTA replaced the defective gate arm immediately after the diagnostic meeting.

15	Missing required warning signage and pavement markings; install immediately	RXR pavement marking has since been installed. A missing W48(CA) sign will be installed (Attachment K).
16	There is no ADA path to the crossing- create an ADA path approaching and into the crossing	See Attachment L for proposed gates. Pedestrian treatments, including expanded sidewalk, are proposed.
17	What type of wall is the developer installing along the rail corridor? It should allow visibility of the rail corridor	The developer installed a chain link fence; it allows for visibility between the sidewalks and rail corridor
18	Is the lower traffic signal head mounted at a compliant height? Appears very low	We reviewed all locations where there is a pole-mounted traffic signal head at a low height over the sidewalk (Sunol, Race, Parkmoor, Fruitdale, Leigh, Stokes). These supplemental signal faces provide extra visibility for drivers of the pre-signal indication. After the striping and signage plans and other planned improvements are implemented, we will evaluate whether these signal heads still provide a benefit or should be removed.

19	Why is there a bollard in the middle of the sidewalk; can it be removed	See Sunol Comment Response #18. The bollard channelizes pedestrians away from walking into the pole-mounted traffic signal head. If City staff determine that this signal head should be removed after improvements are completed, the bollard will be removed with it.
20	Installing complete pedestrian treatments might require relocating the Commission Standard #9 gate closer to the roadway in order to have room behind for the pedestrian treatments	n/a - informational comment
<i>SW quadrant</i>		
21	Fence off all sides of the triangular parcel at the northwest corner of the Auzerals/Sunol intersection to prevent trespassing onto the rail corridor and to help channelize pedestrians to the pedestrian crossings	The adjacent developer is preparing a proposal for improving this triangular parcel. We asked the developer to include channelization elements that deter trespassing.

22	Ensure that the sidewalk approach matches up with recommended widened sidewalk coming from the other side of the tracks	See Attachment L for proposed gates. Pedestrian treatments, including expanded sidewalk, are proposed.

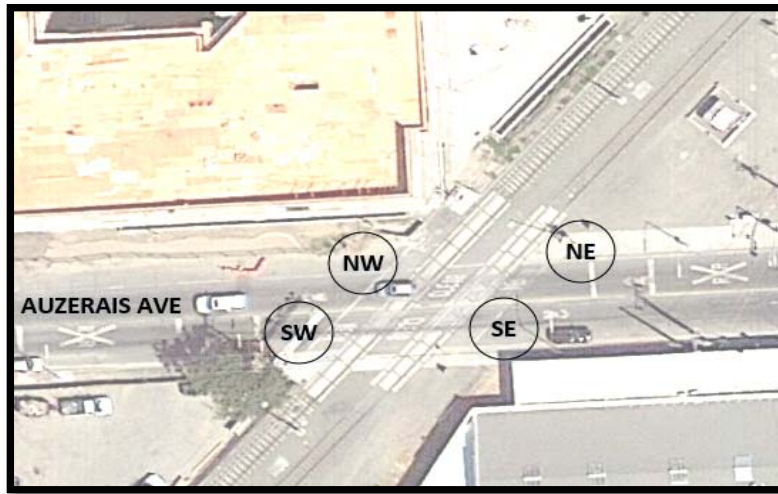
AUZERAIS AVE

Comments		Response
<i>General</i>		
1	Crash History 2007 - 2019: none	n/a - informational comment
2	Land Uses: This area used to be industrial; now it is under construction for high density residential and there is a nearby park, which will generate more pedestrian traffic	n/a - informational comment
3	Adjacent developments and anticipated pedestrian traffic warrant full pedestrian treatments (automated pedestrian gate, pedestrian EXIT swing gate, channelization, and detectable warning strip) at both quadrants on the north side	See Attachment L for proposed gates. Pedestrian treatments are proposed on the north side, but not the south side because of the sidewalk gap. The City would seek new sidewalk and pedestrian treatments on the south side as part of future development applications on the adjacent parcels.
4	Refresh pavement markings (Keep Clear, stop bar, etc.) and ensure up to current standard	See proposed signage and striping plans in Attachment K. Pavement markings, especially stop bars and crosswalks, will be updated to current standard. Faded pavement markings will be refreshed.

5	History: There were a few meetings at Sunol and Auzerai crossings in the past to improve the crossing with the new development; VTA, CPUC, and construction inspectors from City of San Jose attended; developer always disappeared following CPUC and VTA comments; CSJ needs a process to condition upgrades to crossings in planning phase of developments; recently, CSJ obtained \$1M from the developer to use towards improvements at the Sunol and/or Auzerai crossings; CSJ is coordinating with VTA to have VTA construct comprehensive improvements as part of their Pedestrian Back Gates Project and be reimbursed by CSJ	See General Comment Response #14.
6	Proper pedestrian channelization is missing	See Auzerai Comment Response #3.
7	ADA access needs to be addressed	See Attachments K and L. The proposal is to keep pedestrians on the north side of Auzerai between Lincoln Ave and Sunol St. DOT will connect the existing sidewalk gap on the north side of Auzerai to the west of the crossing using striping.

8	Fence off all sides of the triangular parcel at the northwest corner of the Auzerais/Sunol intersection to prevent trespassing onto the rail corridor and to help channelize pedestrians to the pedestrian crossings	The adjacent developer is preparing a proposal for improving this triangular parcel. We asked the developer to include channelization elements that deter trespassing.
<i>NW quadrant</i>		
9	There is a gate arm for a driveway that used to exist but was removed with the new development; the driveway gate extended into the roadway as well, functioning as a quasi-exit gate the developer wanted to remove the gate arm, and met with CPUC and VTA; CPUC wanted the developer to install pedestrian treatments as part of the work; the developer disappeared; City and VTA are coordinating on comprehensive improvements at this crossing as part of VTA's Pedestrian Back Gates project	A GO88b was issued to CPUC and CPUC provided approval to remove the gate arm. VTA has a contractor on board who is working on the programming that needs to be adjusted before the obsolete gate arm can be removed.

10	VTA recently determined that this third gate arm is a pedestrian collision hazard; the gate comes down 7 seconds after the other gates (to allow westbound vehicles to clear the crossing; with the new sidewalk installed, eastbound pedestrians are channelized towards this quadrant and could enter the crossing and get trapped on the tracks by the lowered gate; VTA and the developer have installed barricades on the sidewalk to deter pedestrians from crossing here; City and VTA are coordinating on a GO88 to remove the remnant gate arm in the near-term and re-open the sidewalk	See Auzerais Comment Response #9.
<i>SW quadrant</i>		
11	Replace W10-9P with the standard size consistent with your other locations	See proposed signage and striping plans in Attachment K. This sign will be replaced.
12	There is a tree on the private property side of the fence which is blocking visibility of the crossing warning devices and appears to be in contact with overhead electrical lines; remove this tree or trim it down substantially	This tree will be removed.

13	Remove "Road Construction Ahead" sign mounted on the PG&E pole if it is no longer needed	See proposed signage and striping plans in Attachment K. This sign will be removed.
14	The private property adjacent to this quadrant has a driveway cut; this driveway is too close to the crossing; close the driveway and replace with sidewalk and curb	The owner has agreed to let the City close the two existing driveways on the southwest quadrant of the crossing and install one new driveway at the west edge of the property approximately 120 feet away from the gate arm. See Attachment K.
15	prohibit parking on the curb all the way to the crossing from the property's other driveway	See proposed signage and striping plans in Attachment K. This curb will be painted red.
16	check distance that warning signs are placed relative to crossing	Warning signs are located approximately 90 feet from the stop bar which is consistent with CA MUTCD Table 2C.4 guideline of 100 feet advance placement distance for a street with a 25 mph speed limit.

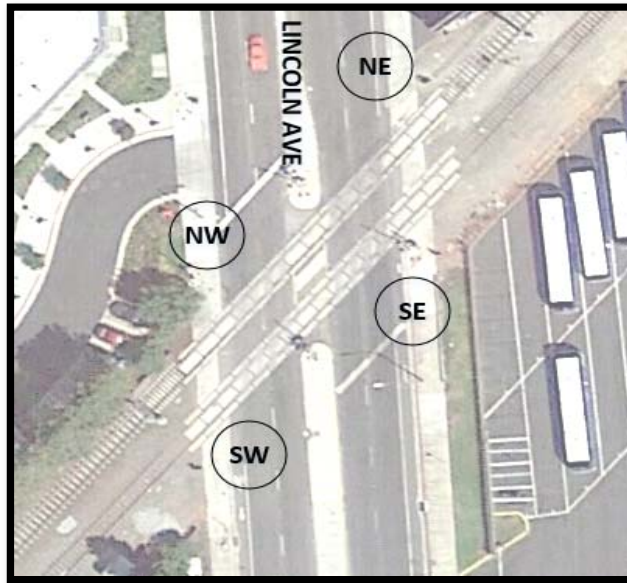
LINCOLN AVE

Comments		Response
<i>General</i>		
1	Crash History 2007 - 2019: • 7/8/18 Double Fatality: driver of vehicle ignored activated warning devices, drove vehicle through gate arms and was struck by LRT, killing both the driver and the passenger of the vehicle	n/a - informational comment
2	Land Uses: multifamily residential, medical, industrial, commercial	n/a - informational comment
3	Driveways to adjacent properties are too close to crossings	The City is working with the property management to close the driveway at the northeast quadrant pending agreement from tenants and Fire Department, and a new parking site plan. If the driveway cannot be closed, City will request that it be marked right-out, exit-only.
4	Any access to adjacent properties that is 60 feet or less from the crossing needs to be eliminated	See Lincoln Comment Response #3. Our quiet zone application proposes a partial risk reduction for the ASM at this crossing due to the driveways.

5	A 4-quadrant gate system would be ideal here because of the cars driving at higher speeds, because of the adjacent driveways on both north quadrants, and because of the adjacent alcoholic establishment	See Lincoln Comment Response #4.
6	Pedestrian gates not prioritized at this location as it does not appear to have high pedestrian flows	n/a - informational comment
7	While diagnostic review was being conducted, a bicyclist ignored warning devices signaling a train was coming and went through the crossing as arm gates were coming down	n/a - informational comment
<i>SE quadrant</i>		
8	change W10-9P sign to our current standard	See proposed signage and striping plans in Attachment K. This sign will be replaced.
9	relocate bus stop and bus stop sign	VTa removed this bus line in December 2019 as part of a new transit service place.

10	gate on sidewalk is missing flashers facing north	Comment for VTA.
11	the gate in the sidewalk and the warning signs crowd the sidewalk and could lead to pedestrians walking behind the sidewalk around the control devices; suggest relocating warning signs and adding pedestrian channelization	See proposed signage and striping plans in Attachment K. The R15-8 sign will be removed.
12	warning signs look big; check dimensions	See proposed signage and striping plans in Attachment K. The R15-8 sign will be removed. The W82-1(CA) and W10-9P signs conform to CA MUTCD size requirements.
<i>NE quadrant</i>		
13	the adjacent plaza has 3 driveways on Lincoln and one driveway on Auzerai; the driveway just north of the crossing is located very close to the tracks and raises the risk of a vehicle driving in opposing traffic across the tracks; also, the establishment in the plaza that is closest to the tracks is an alcoholic establishment; close this driveway if possible	See Lincoln Comment Response #3.

14	if the driveway cannot be closed, add a median mounted "Right Turn Only" sign, stripe the driveway as a right turn out only, add edge lines in the driveway to guide vehicles to turn right out, and modify the driveway to physically force vehicles to turn right as they exit	If the driveway cannot be closed, City will request that it be marked right-out, exit-only, and City will evaluate locating a "Right Turn Only" sign in the median.
<i>NW quadrant</i>		
15	check W10-9P sign for consistency	See proposed signage and striping plans in Attachment K. This sign will be replaced.
16	the residential development should not have been allowed to locate the driveway within proximity of the tracks	See General Comment Response #14.
17	check ADA compliance around gates	This crossing in general was not considered to have high pedestrian volumes and thus was not prioritized for pedestrian treatments.
18	widen the sidewalk to the back to open up an ADA path for pedestrians around the gate	See Lincoln Comment Response #17.

19	the tree right next to the gate is overgrown and blocking visibility of the warning devices; remove it or trim it back considerably and maintain regularly	The City will trim this tree, or follow up with the property management for tree trimming.
20	warning signs look big; check dimensions	See proposed signage and striping plans in Attachment K. The R15-8 sign will be removed. The W82-1(CA) and W10-9P signs conform to CA MUTCD size requirements.
21	gate is missing flashers facing south	Comment for VTA.
<i>SW quadrant</i>		
22	the visibility between this quadrant and the rail corridor is limited because of the tracks skew and trees lining the rail corridor; flashers and bells are needed at this quadrant	Comment for VTA. VTA is considering pedestrian treatments here as part of their Pedestrian Back Gates project.

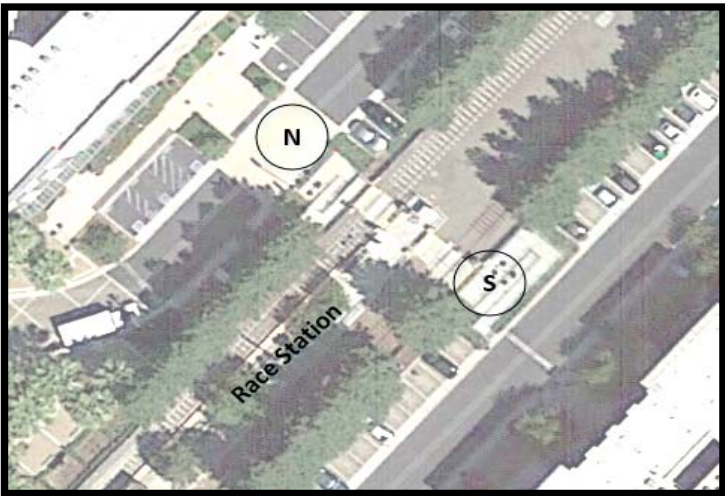
RACE STATION

Comments		Response
General		
1	Crash History 2007 - 2019: none	n/a - informational comment
2	Land Uses: high density residential both sides	n/a - informational comment
3	Detectable warning strips should be outside of the gates; currently they are inside the gates which can give the wrong impression to a vision-impaired user that they are within a “safe zone”	Comment for VTA.
4	The north side of the crossing doesn’t have flashers positioned in advance of the gates; Install Commission Standard #8 flasher	Comment for VTA.

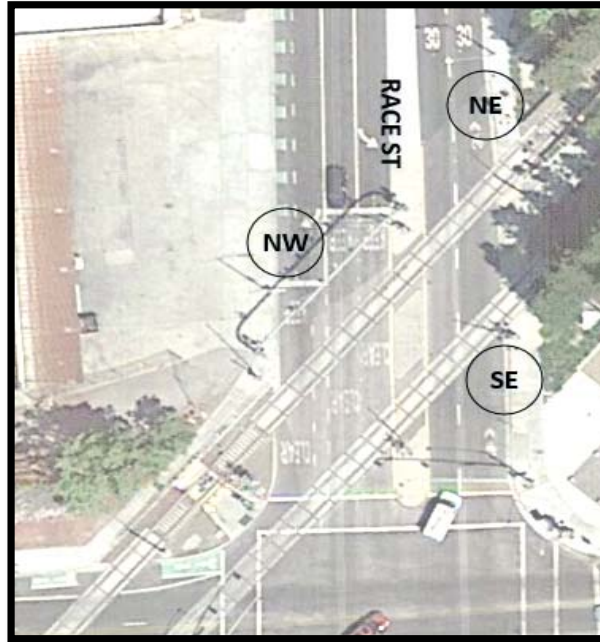
RACE ST

Comments		Response
<i>General</i>		
1	Crash History 2007 - 2019: •2/4/12 Injury: pedestrian suffered injuries when pedestrian entered the crossing while the warning devices were activated and was struck by LRT	n/a - informational comment
2	Land Uses: high density residential and Light Rail station on east side; proposed school with 2700 students on west side; a recently opened school resides on the opposite corner (SE) on the Race and Parkmoor intersection	n/a - informational comment
3	The property on the west side of Race St is proposed for redevelopment into a school of 2700 students; CSJ's conditions on the property redevelopment require the school to utilize crossing guards during school drop off and pick up, to conduct at least annual crossing safety trainings	n/a - informational comment
4	Loading zones, school buses, etc. should be located as far away from the tracks as possible	City staff will carry this comment through the development review cycle for the proposed development on the northwest corner of Race/Parkmoor. The latest plan submittal for the development shows an ingress only driveway on Race St approximately 400 feet north (upstream) of the tracks, and an egress-only driveway on Parkmoor approximately 200 feet west (downstream) of the tracks.

5	City of San Jose Traffic Safety Education Officer, Cordell Bailey, performs frequent trainings at schools in San Jose and will do so at this school after it opens; he is Operation Lifesaver certified	n/a - informational comment
6	This crossing overlaps with the Parkmoor crossing	n/a - informational comment
7	Pedestrian treatments suggested at all quadrants	See Attachment L for proposed gates. Pedestrian treatments at all quadrants are proposed.

8	FRA is concerned with these two crossings (Race & Parkmoor); track and intersection geometry is very challenging to mitigate; multiple collisions, especially at the northwest corner of the Race/Parkmoor intersection; existing school on the southeast corner of the intersection; and now a school going to open on the northwest corner of the intersection. This would be an ideal candidate for grade-separation of the light rail track (e.g. see LRT flyover at Hamilton Ave in San Jose).	The City developed a new plan line for Race St and Parkmoor Ave to improve this location. See Attachment L.
9	Per CPUC, this location would be an ideal candidate for a pedestrian overcrossing.	A pedestrian overcrossing is not preferred because it would require pedestrians to take a longer and less direct path and, is not expected to achieve high compliance at this location. Instead, this crossing will be reconstructed to improve safety for all users at-grade. See Attachment L.

10	FRA prepared a concept for a redesign of the intersection and crossings that they would like to share with the group	City obtained the concept from FRA. The concept relocates the north leg and west leg crosswalks to the north and west sides of the tracks, respectively. This was one of two concepts that City staff evaluated. City staff determined that in order for the crosswalks to operate safely and be protected from right-turning drivers, they would need to be signalized and have an exclusive pedestrian phase coinciding with an all-red for the rest of the intersection. City staff determined that this would yield an unacceptable impact on operations, noting that the signal already experiences all-red over 160 times per day with each LRT movement through the intersection. This type of impact would be expected to result in driver frustration and violations of the signals, which would put pedestrians at more risk. Instead, this crossing will be reconstructed per the concept in Attachment L.

11	City of San Jose geometrics team has prepared some concepts for a redesign of the intersection and crossings that we will share with the group after they have gone through internal city review	See Attachment L. This concept has been coordinated with FRA, VTA, and CPUC. The City will continue to coordinate the design with the stakeholders as it progresses.
12	Suggest adding a controlled crosswalk mid block north of the tracks and a minimum of 200 feet away the crossing to enable students/pedestrians to cross Race St between the school side and the LRT station side without having to cross the tracks	See Attachment L. City staff considered a mid block crosswalk on Race St north of the crossing, but ruled it out for safety reasons due to the three back-to-back left-turn pockets.
13	Overall, FRA understands that there are efforts underway to improve the crossing (proposed improvements to be conditioned on school development, CSJ geometrics team evaluating intersection reconfiguration options), and requests CSJ engage FRA and CPUC in that ongoing work	See Race Comment Response #11.

14	Median dividing northwest and northeast quadrants does not meet curb height requirements	The City of San Jose will add channelizers onto the median islands in the near term. In the long term, the median islands will be reconstructed to a minimum 8" height as part of the proposed development on the northwest corner of Race/Parkmoor.

15	Gate does not meet current MUTCD standard clearance required between the center of the pole and the face of curb	See Attachment L. This gate arm would likely be replaced.
<i>NW quadrant</i>		
16	The proposed development should not be allowed to have any driveways within 100 feet of the crossing	See Race Comment Response #4.
17	Southbound vehicles on Race often miss the stop bar for the pre-signal; need to refresh pavement markings; check if signage, pavement markings, etc. can be modified to yield higher driver compliance. Possible candidate to install crosshatch pavement markings.	See proposed signage and striping plans in Attachment K. In the near-term, the stop bar will be relocated and signal heads will be evaluated.

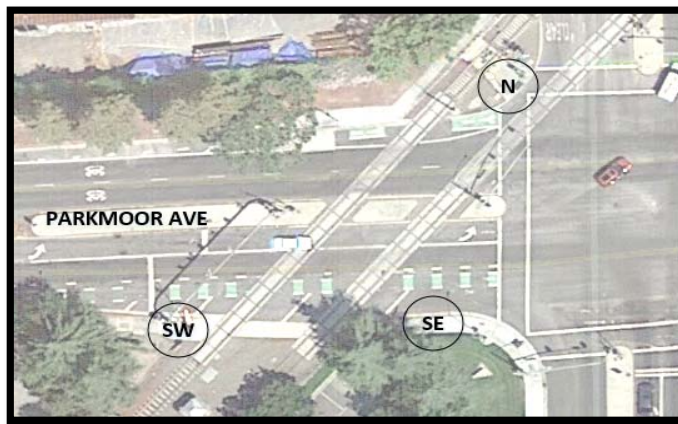
PARKMOOR AVE

Comments		Response
<i>General</i>		
1	<p>Crash History 2007 - 2019:</p> <ul style="list-style-type: none"> •10/27/10 Injury: pedestrian suffered injuries when pedestrian ignored activated warning devices, went through gate in north quadrant and was struck by the LRT •2/23/13 Injury: bicyclist suffered injuries when bicyclist ignored activated warning devices, rode through pedestrian crossing in north quadrant, and was struck by the LRT •4/20/16 Injury: pedestrian suffered injuries when pedestrian ignored activated warning devices, went through gate in north quadrant, and was struck by the LRT •7/29/17 Fatality: eastbound bicyclist traveling in the westbound lanes ignored activated warning devices and was struck and killed by northbound LRT •3/23/18 Injury: pedestrian suffered injuries when pedestrian ignored activated warning devices, went through gate in north quadrant, and was struck by the LRT 	n/a - informational comment

2	Land Uses: office to the south; proposed school with 2700 students to the north	n/a - informational comment
3	Overall, FRA understands that there are efforts underway to improve the crossing (proposed improvements to be conditioned on school development, CSJ geometrics team evaluating intersection reconfiguration options), and requests CSJ engage FRA and CPUC in that ongoing work.	See Attachment L. This concept has been coordinated with FRA, VTA, and CPUC. The City will continue to coordinate the design with the stakeholders as it progresses.
4	Pedestrian treatments suggested at north quadrants especially; south quadrants don't appear to have enough ped traffic to warrant full treatments with automatic pedestrian gates.	See Attachment L for proposed gates. Pedestrian treatments at all quadrants are proposed.
<i>N quadrant</i>		
5	Pedestrians walking along the north side of Parkmoor Ave and crossing the tracks at Race St have a high rate of going around the pedestrian swing gates and refuge; consider shifting this crosswalk on the north leg of the intersection southerly to align with the pedestrian desire line and bring both tracks into the crosswalk signal at the northwest corner of the intersection	See Attachment L for the proposed improvements.

6	Can Sheriff or Police do more enforcement of violations?	County police perform regular sting operations at this location.
7	While diagnostic review was occurring, an individual in a wheelchair traveling southbound on Parkmoor across Race Street ignored crosswalk path and traveled parallel with the road. Suggest re-channeling pedestrians through this crosswalk.	See Attachment L for the proposed improvements.
<i>SE quadrant</i>		
8	Add Commission Standard #8 flasher to this quadrant as a near-side warning device for pedestrians approaching the crossing	See Attachment L for the proposed improvements.
9	Extend the chain link fence that runs along the rail corridor all the way to the back of sidewalk	This will be incorporated into the proposed improvements (Attachment L) as that design progresses.
10	Add a fence along the back of sidewalk between the intersection and the crossing to channelize pedestrians.	This will be considered with the proposed improvements (Attachment L).

<i>SW quadrant</i>		
11	Standardize signage	See proposed signage and striping plans in Attachment K.

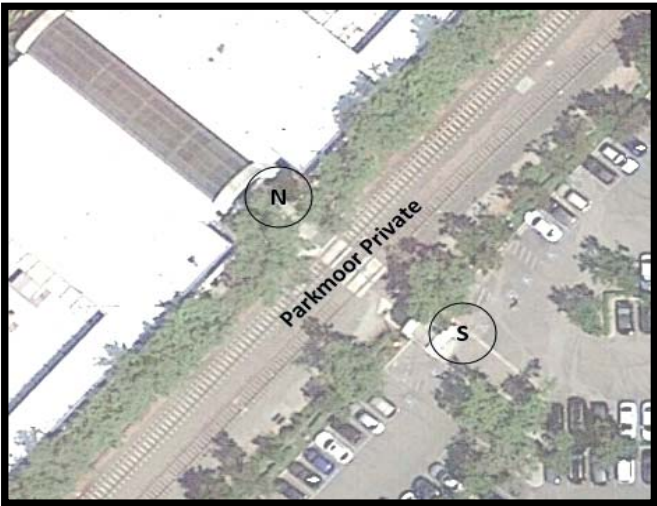
PARKMOOR PEDESTRIAN

Comments		Response
General		
1	Crash History 2007 - 2019: none	n/a - informational comment
2	Land Uses: office building to the north and associated parking lot to the south	n/a - informational comment
3	Current swing gates are chain link and camouflage with the fence; convert to VTA standard swing gate	Comment for VTA.
4	There are multiple surfaces across the tracks (asphalt, ballast, concrete); repave to make one, consistent smooth surface (e.g. see Fruitdale Station); refresh paint for edge lines that line the crossing over the tracks	Comment for VTA.

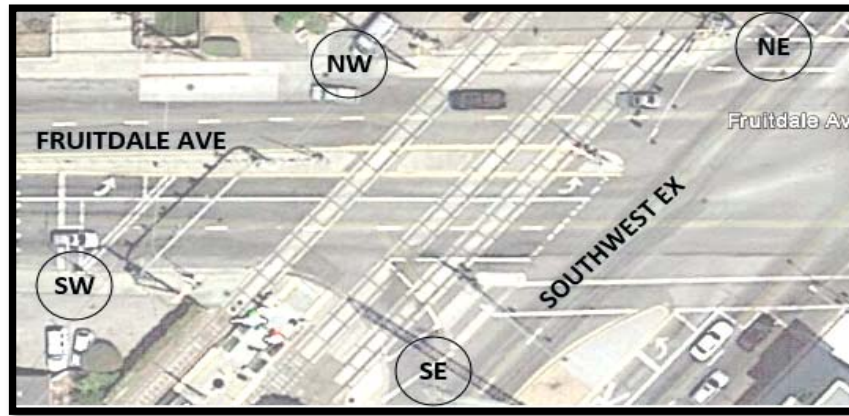
FRUITDALE AVE

Comments		Response
<i>General</i>		
1	Crash History 2007 - 2019: •10/5/18 Injury: pedestrian suffered injuries when pedestrian ignored activated warning devices and was hit by LRT in quadrant	n/a - informational comment
2	Land Uses: multifamily residential all quadrants; LRT station to the south	n/a - informational comment
3	Lots of disabled and medical patients and emergency vehicles pass through this crossing from the Valley Medical Center one mile to the east	n/a - informational comment
4	Do crossings have power off indicators? VTA: they have live monitoring from OCC	n/a - informational comment
5	Dynamic Message Signs "No Right Turn" should be upgraded to the current R3-1 Activated Blank Out Sign standard with the next modification to this crossing's electrical devices	n/a - informational comment
6	There is an LRT station very close to this crossing; there is a pedestrian barricade along the median island to discourage jaywalking across Fruitdale; however there is no crosswalk on the west leg of the intersection; wonder if these conditions are encouraging pedestrians to cross Fruitdale by walking along the tracks (rather than using 3 crosswalks at the intersection); how can we improve it	See proposed signage and striping plans in Attachment K. A crosswalk on the west leg of Southwest Ex/Fruitdale Ave intersection could not be accommodated in the design and construction of the Vasona LRT corridor due to the proximity of the tracks to the intersection. While DOT does not recommend uncontrolled mid-block crosswalks across streets with 4 or more lanes, the pedestrian demand and non-compliance here triggered a more comprehensive analysis to provide a safe pedestrian crossing at this location. DOT will install a new enhanced crosswalk with bulb-outs, median refuge island, and rectangular rapid flashing beacons on Fruitdale Ave at College Dr, approximately 460 feet west of the tracks, to be implemented in 2020.

7	<p>While diagnostic review was being conducted a truck and 2 cars became stuck between activated arm gates and intersection at both the Southeast and Northeast quadrants indicating the timing of the signals needs to be adjusted to allow vehicles to adequately clear the area</p>	<p>Track Clearance timing doesn't start after the gates are down, but before that, in order to let the vehicle to pass and clear the intersection. During the diagnostic review at this intersection, the timing settings for preemption events were checked and were found to be adequate. The preemption log was shown to FRA and CPUC representatives.</p> <p>Also, see proposed signage and striping plans in Attachment K. For the eastbound movement, the pre-signal stop bar will be relocated, the downstream stop bar eliminated, and Keep Clear pavement markings added at the tracks. These striping changes should reduce the amount of eastbound drivers crossing the tracks after the pre-signal turns red and track clearance is underway.</p>

8	<p>While diagnostic review was occurring, members of the team became caught between the light and the gate arm at the northwest and northeast quadrants indicating the timing of the signals needs to be adjusted to allow pedestrians to clear the area</p>	<p>The crossing across the rail tracks is not signalized, therefore the pedestrian crosswalk timing on the north leg of the intersection does not include time to cross the tracks. We acknowledge that the pedestrian storage space at this corner between the gate arm and the curb is limited. Further, there is no crosswalk on the west leg of the signalized intersection. To accommodate pedestrian movements across Fruitdale, DOT will install a new crosswalk on Fruitdale Ave, approximately 460 feet west of the tracks. This will serve pedestrians between the residential neighborhoods to the north and the LRT station to the south. By using this crosswalk, most pedestrians will not need to travel through the northwest corner of the signalized intersection where the storage space is limited.</p>

<i>SE quadrant</i>		
9	<p>EB Fruitdale drivers tend to violate the pre-signal; adjust the louvers on the far-side traffic signal heads so that upstream drivers don't see the green light until they pass the pre-signal</p>	<p>See proposed signage and striping plans in Attachment K. The stop bar will be relocated and signal heads will be evaluated.</p>
10	<p>Check track clearance green time for EB Fruitdale is set correctly in traffic signal controller</p>	<p>See Fruitdale Comment Response #7.</p>
11	<p>refresh paint for edge lines that line the crossing over the tracks</p>	<p>Comment for VTA.</p>
12	<p>Fruitdale EB right is high speed and has low visibility with pedestrians at the corner or pork chop; crosswalk between the corner and the pork chop is also problematic because it leads pedestrians into the tracks without any other protection or warning devices besides a detectable warning strip; suggest reconfiguring the geometry, e.g. bring the curb out into the roadway to expand the ped refuge on the sidewalk, cut the pork chop island back, and add full pedestrian treatments with Commission Standard 9 pedestrian gates, EXIT swing gates, and channelization on the sidewalk</p>	<p>See proposed signage and striping plans in Attachment K. Eastbound right turn edge line striping will be shifted to narrow the lane, slowing down traffic, and making the vehicle lane meet the crosswalk closer to a 90-degree angle rather than a sweeping curve. Raised pavement markers are added on the edge striping to emphasize this effect. The existing No Turn On Red sign at the pre-signal is replaced with the graphical equivalent, R13A (CA). The placement of the Stop Here on Red sign is corrected to be below the R13A (CA) instead of above.</p>

13	There is a streetlight in the sidewalk that is blocked by the tree	Trees have been trimmed.
<i>NE quadrant</i>		
14	W10-4 is blocked by trees; trim trees	Trees have been trimmed.
15	Pedestrian refuge in the sidewalk is extremely small; very little space for even one person to wait while gate is down	See Fruitdale Comment Response #8.
16	Refresh pavement striping	See proposed signage and striping plans in Attachment K.
17	Southbound right turn queue backs up in the peak and drivers often violate the "No Right Turn" sign which is activated with the crossing devices	There is a vehicle gate arm and median island that prevent drivers from circumventing the gate arm.
<i>NW quadrant</i>		
18	Driveway closest to the crossing should be striped as a right turn out only; add edge lines in the driveway to guide vehicles to turn right out, and physically modify the driveway to force vehicles to turn right as they exit	See proposed signage and striping plans in Attachment K. A Right Turn Only sign for the westerly driveway will be added. The westerly driveway cannot be physically modified to force a right turn out because it is also used as an entrance driveway for vehicles turning right in.

19	This pedestrian gate is an old design; if upgraded, the new design should include a swing gate next to the automatic gate and channelization	n/a - informational comment
20	Warning signs are located very close to the sidewalk, partially obstruct sidewalk path	See proposed signage and striping plans in Attachment K. The R15-8 sign will be removed.
<i>SW quadrant</i>		
21	Change "No Train Horn" sign located under the W10-1 to standard dimension	See proposed signage and striping plans in Attachment K. This sign will be replaced.
22	Refresh pavement markings on EB Fruitdale	See proposed signage and striping plans in Attachment K.
23	"No Train Horn" and "Look Both Ways" warning signs mounted on sound wall are covered by ivy; relocate to pole mount	See proposed signage and striping plans in Attachment K. These signs will be relocated.

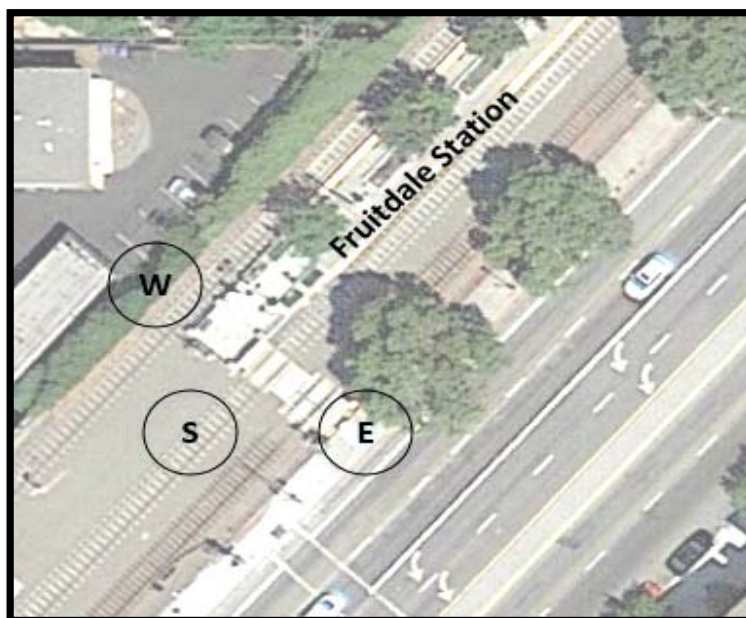
FRUITDALE STATION

Comments		Response
<i>General</i>		
Crash History 2007 - 2019:		
1	•6/26/09 Fatality: pedestrian ignored activated warning devices, went through push gate and was hit and killed by LRT	n/a - informational comment
2	Land Uses: multifamily residential	n/a - informational comment
3	Detectable warning strips should be outside of the gates; currently they are inside the gates which can give the wrong impression to a vision-impaired user that they are within a "safe zone"	Comment for VTA.
4	Standardize sign configuration and placement	Comment for VTA.
5	Move ENS to pole at dead-end of station platform; move No Trespassing sign from pole at dead-end to somewhere else	Comment for VTA.
6	Fix or maintain swing gates	Comment for VTA.
7	Refresh paint for edge lines that line the crossing over the tracks between the swing gates	Comment for VTA.
8	Relocate Look Both Ways sign from pole at dead-end of platform because peds can only exit to the left; also sign blocks visibility of oncoming trains	Comment for VTA.

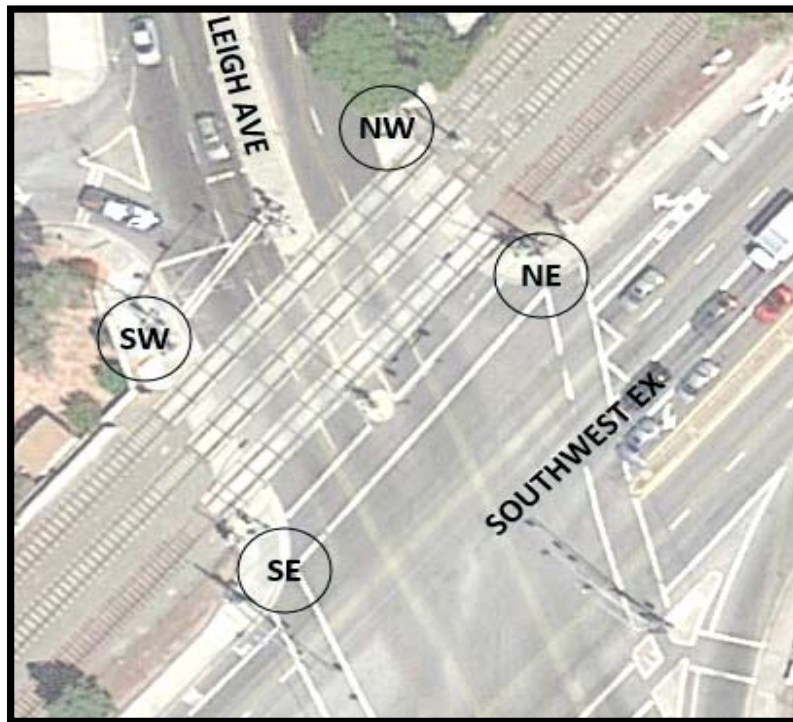
LEIGH AVE

Comments		Response
<i>General</i>		
1	Crash History 2007 - 2019: o 6/18/09 Fatality: pedestrian ignored activated warning devices, went around vehicular gate arm and was struck and killed by LRT o 1/2/11 Fatality: pedestrian ignored activated warning devices, ran across the tracks and was hit and killed by LRT	n/a - informational comment
2	Land Uses: residential, gas station, proposed commercial and senior housing	n/a - informational comment
3	This crossing is ideal for a 4-quadrant gate system because of the number of fatalities, the intersection with Cheney Dr very close to the crossing negating raised concrete median, and the high amount of traffic. The only location an exit gate could be installed in the NW quadrant is on the north median	This quiet zone application proposes a partial risk reduction for the ASM at this crossing due to Cheney Dr intersection. Vehicle exit gates were prioritized at other locations on the corridor.

<i>SW quadrant (where Cheney intersects Leigh)</i>		
4	On Cheney Dr, update W10-9P and place under W10-4; add W48 CA (3 Tracks) under W10-4; rotate W10-4 (Immediate action item)	See proposed signage and striping plans in Attachment K. These changes are reflected.
5	Remove W10-1 (since W10-4 is the appropriate sign here) (Immediate action item)	See proposed signage and striping plans in Attachment K. This sign will be removed.
6	Update W10-9Ps mounted on streetlight poles at crossing and at RXR pavement marking to standard size	See proposed signage and striping plans in Attachment K. These changes are reflected.

21	Signal box blocks visibility between trains and sidewalk; ideally it would not have been placed here	The general comment that signal box location is important as it relates to visibility between the crossing and the rail corridor is noted and will be considered in design of new crossings and redesign of existing crossings.
22	There is a space between the signal box and the fence behind it; shrubbery obstructs view of it; this space should be maintained and monitored to prevent criminal activity or tampering with the crossing	Comment for VTA.
23	Trim the tree behind the signal box	Comment for VTA.
24	There is a No Trespassing sign on the fence behind the signal box; trim the foliage blocking the sign and also consider relocating the sign	Comment for VTA.
25	Remove the non-compliant No Train Horn sign and pole; there is already a (compliant) No Train Horn sign within 10 feet of it	See proposed signage and striping plans in Attachment K. This sign will be removed.

26	Relocate the bus stop which is located about 90 feet west of the crossing; stopped buses can cause vehicles to queue over the tracks	VTA removed this bus line in December 2019 as part of a new transit service place.

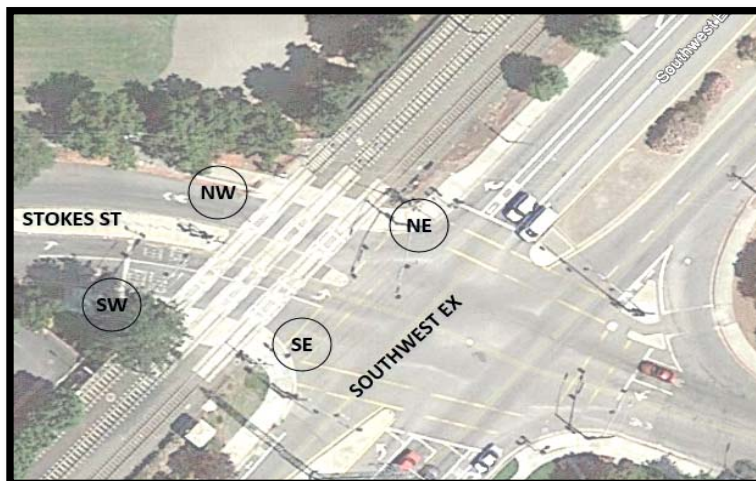
STOKES ST

Comments		Response
<i>General</i>		
1	<p>Crash History 2007 - 2019:</p> <ul style="list-style-type: none"> o 1/7/14 Fatality: bicyclist ignored activated warning devices, went around vehicular gate arm and was struck and killed by LRT o 6/22/14 Fatality: pedestrian ignored activated warning devices, went around gate and was struck and killed by LRT o 7/13/19 Injury: bicyclist suffered injuries when bicyclist ignored activated warning devices, went under vehicular gate arm and was struck by LRT 	n/a - informational comment
2	Land Uses: Del Mar High School, multifamily residential	n/a - informational comment
3	This crossing is packed in the morning with students	n/a - informational comment
4	VTA does regular crossing safety education for Del Mar High School	n/a - informational comment
5	FRA would like to participate in the education event	See Stokes Comment Response #6. FRA has been notified.
6	FRA suggests that the high school have two crossing safety trainings per year	Our traffic safety training officer, Cordell Bailey, provides hundreds of safety trainings at schools and centers in San Jose every year. He is Operation Lifesaver certified and is performing outreach at Stokes/Southwest Ex intersection adjacent to Del Mar High School and at Leigh/Southwest Ex in February 2020. His intention is to conduct outreach at the high school annually.

7	This crossing is ideal for a 4-quadrant gate system and full pedestrian treatments at all quadrants because of the large student volumes, and because some students tend to cross the roadway intersection at a diagonal and circumvent the entry gate	See Attachment L for proposed gates. Pedestrian treatments are proposed at all quadrants. An exit gate is proposed on the east leg.
8	Consider a speed reduction for trains at this crossing; speed might already be low because of nearby station	Comment for VTA.

9	The traffic signal cycle seems long; long signal cycles encourage violations; check if it should be shortened	This intersection runs in free operations for a majority of the day, including the time of the field visit; this means that the cycle length is not fixed, but rather determined by the vehicular/pedestrian demand. The max length of each phase is capped at a relatively low amount of time. It may be possible that a preemption event caused what was perceived as a long cycle length for phases that conflict with the rail movement. The timing settings for preemption events were checked and were found to be adequate.
10	A passerby told us of his 20 years driving through this crossing and tending to a pedestrian fatality that he said happened because the signal box on the southeast quadrant blocked visibility	The general comment that signal box location is important as it relates to visibility between the crossing and the rail corridor is noted and will be considered in design of new crossings and redesign of existing crossings.

<i>SW quadrant</i>		
17	There is a fence between the rail corridor and the adjacent residential property; approximately the first fifty feet of the fence is tall and not-transparent; can this be shortened in height or replaced with a transparent fence to enhance visibility between the roadway/sidewalk and the rail corridor	Other improvements were prioritized at this location (see Attachments K and L).

22	There is a signal cabinet along the rail about thirty-five feet behind the sidewalk; Signal box blocks visibility between trains and sidewalk; ideally it would not have been placed here	The general comment that signal box location is important as it relates to visibility between the crossing and the rail corridor is noted and will be considered in design of new crossings and redesign of existing crossings.
<i>NE quadrant</i>		
23	Gate arm is too short; the tip should be a maximum of one foot from the median island (immediate action item for VTA to correct)	Comment for VTA.
24	Replace the damaged reflector on the median island (immediate action item for CSJ)	See proposed signage and striping plans in Attachment K. This is reflected.
25	Ideally there would be better pedestrian accommodation, including a wider refuge area here, pedestrian gates, and a wider paved area crossing the tracks	See Attachment L for proposed gates. Pedestrian treatments are proposed at all quadrants.

26	The problem with vehicular gates located behind the back of sidewalk is that once the arm comes down over the sidewalk pedestrian can become trapped on the tracks. There is no emergency path (like an EXIT swing gate) for a pedestrian in a crossing to exit from	See Attachment L for proposed gates. Pedestrian treatments are proposed at all quadrants.
27	Remove the W10-1; consolidate the W10-4, W48(CA), and W10-9P onto one pole	See proposed signage and striping plans in Attachment K. This is reflected.
<i>NW quadrant</i>		
28	Trim trees	Trees have been trimmed.
29	Pedestrian channelization looks good	n/a - informational comment

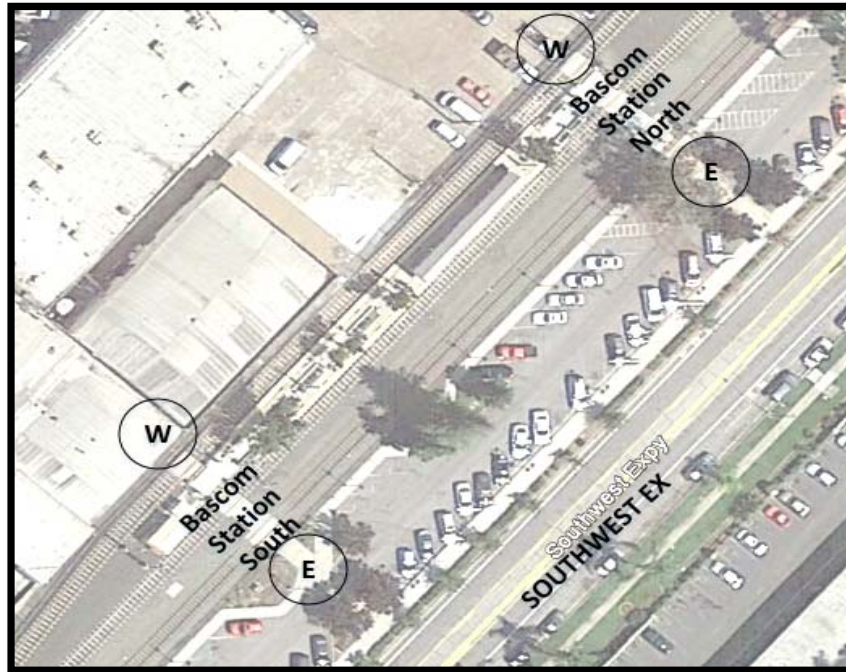
BASCOM STATION-NORTH & BASCOM STATION-SOUTH

Comments		Response
<i>General</i>		
1	Crash History 2007 - 2019: none	n/a - informational comment
2	Land Uses: multifamily residential; development proposed on the triangular parcel to the northwest of Bascom LRT Station will provide pedestrian access to both station entrances; the development includes 600 residential units, 300,000 square feet of commercial space, and a 200,000 square feet office building	n/a - informational comment
3	CPUC submitted a comment letter to City of San Jose Planning on 8/5 in which it recommended that the proposed development on the northwest quadrant: o Install Commission Standard 9 pedestrian automatic gates with EXIT swing gates and channelization at both pedestrian station crossings. o Relocate the detectable warning strips outside of the swing gates at the two pedestrian station crossings.	The developer must provide direct access to one or both station platforms from the development site per the City's permit conditions. The developer, City, and VTA have been in close coordination for two years, and the developer understands that they need to work with VTA and CPUC to modify the station crossing(s). The developer scheduled a field diagnostic with CPUC, VTA, and the City on 1/17/20.

4	Consider standard sign set up at all station crossings; perhaps move "Look Both Ways" and "No Train Horn" signs to swing gates	City is currently coordinating signage and striping plans with VTA.
5	Crossbuck signs on posts need to be rotated to face pedestrians coming from outside the crossing- rotate or add another crossbuck sign facing the nearest approach	Comment for VTA.
6	Replace signs damaged with graffiti (immediate action item)	Comment for VTA.
7	Swing gates need maintenance (immediate action item)	Comment for VTA.
8	Striping across tracks to delineate edge of pedestrian path needs to be refreshed	Comment for VTA.
9	Relocate detectable warning strips to outside of crossing	Comment for VTA.

11	Blue ENS should be relocated to the post with the crossbucks as is typical at other ped crossings	Comment for VTA.
----	---	------------------

12	There is a "Look Both Ways" sign in between the tracks; consider removing, or relocate to swing gate	Comment for VTA.
----	--	------------------

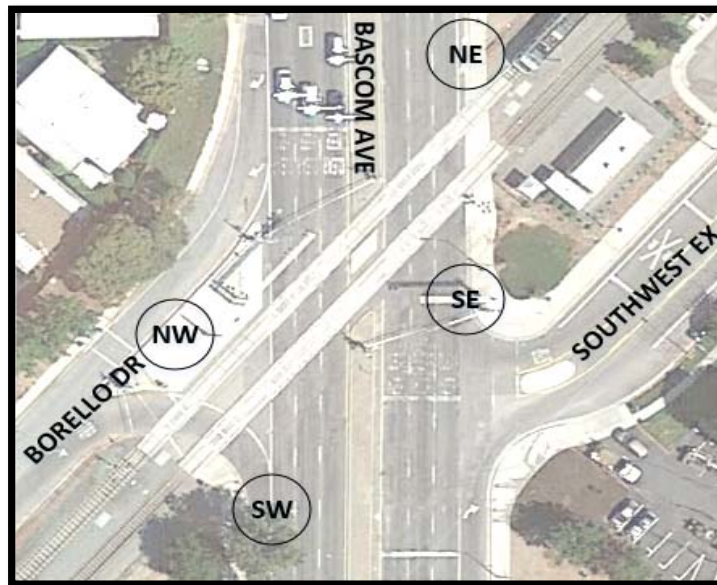
BASCOM AVE

Comments	Response
<i>General</i>	
<p>Crash History 2007 - 2019:</p> <p>1 • 3/10/17 Injury: pedestrian suffered injuries when pedestrian ignored activated warning devices and was struck by LRT</p>	n/a - informational comment
<p>2 Land Uses: residential; there is a development proposed adjacent to the northeast quadrant of the crossing; it includes 600 residential units, 300,000 square feet of commercial space, and a 200,000 square feet office building</p>	n/a - informational comment
3 Big and awkward intersection	n/a - informational comment
<p>4 CPUC submitted a comment letter to City of San Jose Planning on 8/5 in which it recommended that the proposed development on the northwest quadrant: Install Commission Standard 9 pedestrian automatic gates with EXIT swing gates and channelization on the sidewalk approaches at the South Bascom Ave crossing in the NE and SE quadrants</p>	n/a - informational comment

5 Refresh pavement markings all approaches	See proposed signage and striping plans in Attachment K. Faded pavement markings will be refreshed.
6 This section is part of VTA's "Bascom Complete Streets" study	n/a - informational comment
<p>7 While diagnostic review was occurring, a pedestrian ignored the activated warning devices and ran across the tracks, making it safely to the other side. When questioned as to why she ignored the warning devices she indicated that she had already started to cross. When questioned whether crossing arms or pedestrian gates would have stopped her from crossing she said yes...if she wasn't already in a hurry.</p>	n/a - informational comment
<i>SE quadrant</i>

8	Remove the young tree next to the “No Right Turn” LED sign on Southwest Ex; the tree blocks visibility of the crossing and will block visibility of the LED sign as it grows bigger (immediate action item for VTA)	Comment for VTA.
9	Signal box blocks visibility between trains and travel way; ideally it would not have been placed here	The general comment that signal box location is important as it relates to visibility between the crossing and the rail corridor is noted and will be considered in design of new crossings and redesign of existing crossings. Also, see Attachment L. Pedestrian treatments are proposed on all quadrants.
10	Full pedestrian treatments are warranted on the east side of Bascom because of the increased pedestrian traffic anticipated with the proposed development and because the signal box blocks visibility	See Attachment L for proposed gates. Pedestrian treatments are proposed at all quadrants.

11	There is a detectable warning strip located about 25 feet upstream of the track and 15 feet upstream of the flashers; this is too far from the crossing for pedestrian compliance and for visibility with the rail corridor; relocate closer to the crossing along with other pedestrian treatments recommended here	This will be incorporated into the proposed pedestrian treatments.
12	There is an informal pedestrian path that cuts across the triangular landscaping section between this quadrant and Southwest Ex; this path circumvents the advance warning devices (flashers); ensure any pedestrian treatments at this quadrant address this path as well	See Attachment L. This will be addressed as part of the proposed pedestrian treatments.
<i>NE quadrant</i>		
13	Recommend full pedestrian treatments to serve increased traffic anticipated with the new development and to match those treatments at the SE quadrant	See Attachment L for proposed gates. Pedestrian treatments are proposed at all quadrants.
